Crack Branching in Catastrophic Fractures of Metal Structures and Environmental Damages

In this article, fracturing in large-scale metal structures such as main gas pipelines, fuel and oil tanks operated in Arctic were investigated. It is shown that catastrophic accidents involved in large thin-walled metal structures in large diameter pipelines, tanks and pressure vessels. The fractures occurred not only due to stretch propagation of brittle or viscous fractures, but also followed branching that leads to fragmented fractures with simultaneous movement of many cracks. The character of the fracture depends on the level of the fracture strength. At high levels cracks propagated at a high speed by a mechanism of separation; as a result of crack branching fragment damage occurred. At low level, cracks propagate at a low speed by a cutting mechanism; that does not cause extensive fracturing. The cracks may cause structural and environmental damages.

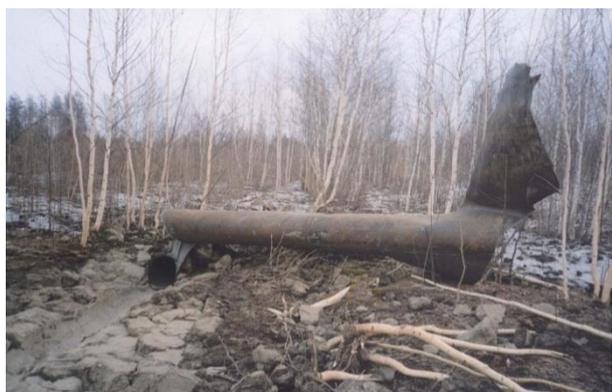
The fracture of the main gas pipeline occurred in spring of 2003, by crack propagation along the pipeline on top with numerous branches (Figure 1). The fracture was of an explosive character without fire; the crack propagated by a mechanism of separation and on the ground cracks stopped passing onto the shift mechanism with plastic components.

Figure 1. Fracture of the main gas pipeline

According to the act on technical investigation (TI) of accidents and incidents (here after referred as "Act TI") carried out by the expert organization [6], which was attended by the authors of this article. The main reason for the failure was the fatigue defects located on the inner side perpendicular to the mounting ring weld in the heat-affected zone at the junction of the base metal and the weld, having a sufficient length and evidencing long-term growth of the crack (Figure 2). In fact, the pipeline was built in 1970–1980; from steel pipes with a diameter of 5.3m and wall thickness of 7–8 mm. Spectral analysis revealed that the collapsed pipe materials comply with the following grades of steel: pipe №1 – 17G1S; pipe №2 – 09G2S. The greatest fracture occurred on the base material steel 17G1S.

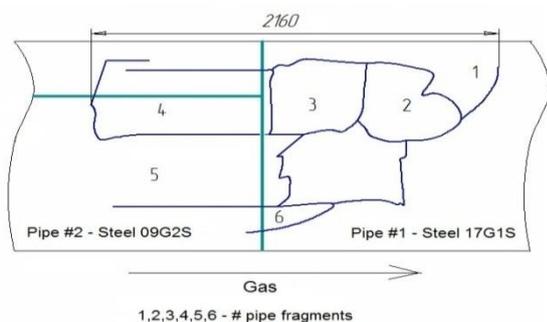
Figure 2. Schematic drawing of fracture: the main gas pipeline

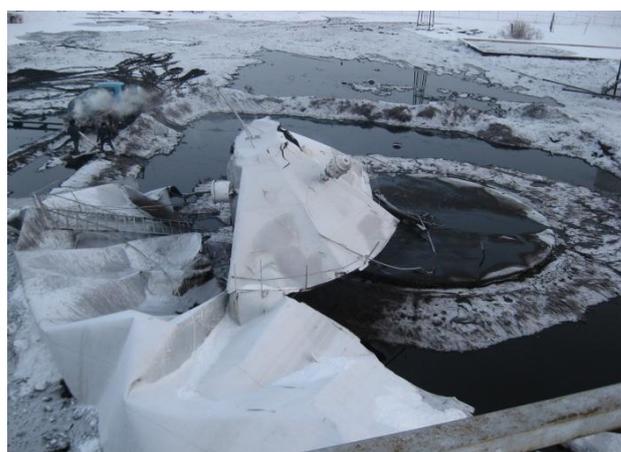
Fracture of the vertical steel tank (RVS) №49 with a volume of 700 m³ occurred in December 2007; when the outdoor temperature was –35 °C with a wind speed of 1–2 m/s in north-east direction. It was caused by the development of a crack on the base metal tank wall in the vertical direction on the heat-affected zone of weld connections (from the wall to bottom, from the wall to roof). As a result, the tank wall was torn from the bottom around the weld, cut off from the roof perimeter (30 m long), rolled and dropped 10 m in a southwest direction (Figures 3 and 4). The flooded crude oil quantity was approximately 422 tonnes. The oil spillage

According to the Act TI of expert organisation [6], the fracture was caused by a number of factors: the aging of the metal tank, which manifests itself in embrittled metal; lowering of the ambient temperature to –42°C; planar crack in the wall of the tank from the discontinuous metallurgical nature with location in the base metal, which had the character of fatigue during operation with direct access to the outer surface of the tank wall.

Figure 3. Fracture of the vertical tank RVS-700 №49 with capacity of 700 m³.

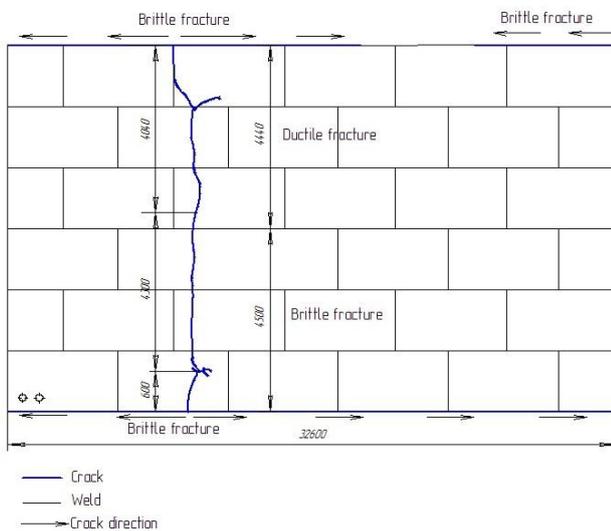
Figure 4. Schematic of the vertical tank fracture, RVS-700 №49

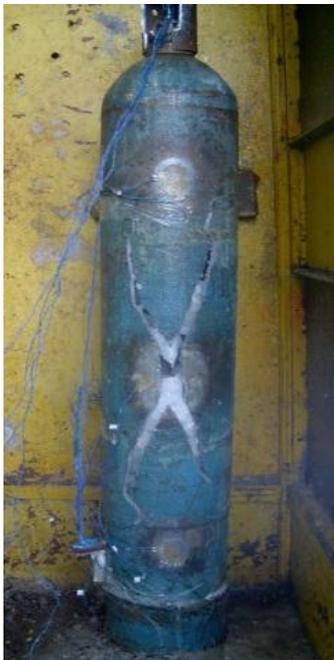
During vessel testing, crack propagation initiated from the notch in all cases (Figure 5). Depending on the notch length, the experiment lasted from 8 to 25 hours. According to strain gauge readings, elastic lateral deformation reached to 0.2% at pressures of 38, 32, 30, and 18 MPa for vessels with notches 50, 60, 70, and 90 mm long, respectively; further deformation was plastic. Longitudinal deformation remained within the elastic range until vessel fracture. According to thermocouple readings, the average temperatures were: ambient air: -20°C , vessel walls at fracture: -5°C , and inside vessel at fracture position: -3°C , which are comparable to the operating conditions for underground trunk lines in the permafrost zone.

Figure 5. The crack branching in steel pressure vessel

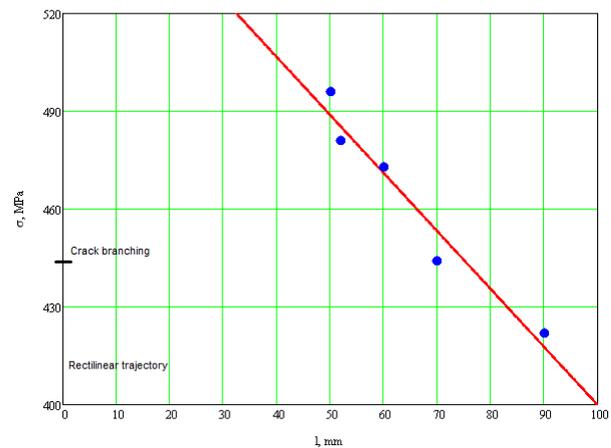
The experimental and calculated data shows that crack propagation mode in vessels depends on the level of internal pressure P (fracture stress σ): at $P < 23$ MPa ($\sigma < 422$ MPa), crack propagation is rectilinear; at critical level of internal pressure $P > 31$ MPa (critical level of fracture stress $\sigma > 444$ MPa) crack propagation is observed along two branches, forming an angle (see Figure 6).

Figure 6. Dependence of a fracture stress σ on the notch length l
