Advances in Saltmarsh Restoration

I. Reeder*, W. Coulet, D. Miko, J. Thomas, G. Hopkins

Exo Environmental, The Enterprise Centre, University of East Anglia, Norwich, NR4 7TJ, United Kingdom

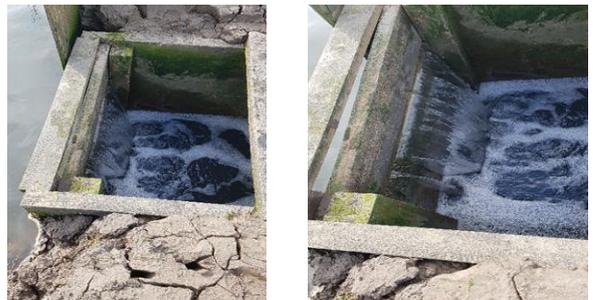
Figure 2. Sluice boxes installed at the SOP. Note the filtering of clean surface water

To ensure the SOP were secure and ready to receive the dredged material, 9 bespoke sluice boxes were installed, allowing for the controlled release of tidal waters. This facilitated the release and skimming of 'clean' surface water once the fine-grained sediment settled out of suspension (Figure 2).

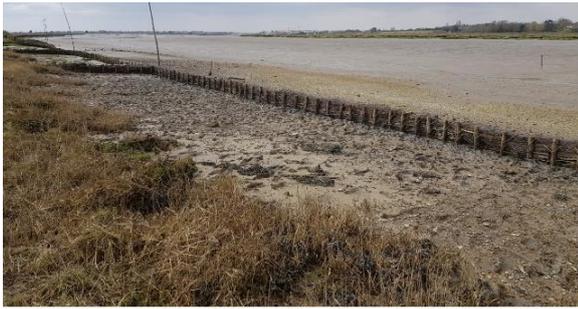
Figure 3. Brushwood fascine compartments prior to filling, as used at Cindery Island West

Brushwood fascines (Figure 3) were constructed adjacent to restoration compartments on Cindery West, to slow the flow of erosive wave energy and encourage deposition of sediment. This resulted in the vertical accretion of sediment providing a suitable substrate for saltmarsh development. The brushwood also provided compartmentalized areas suitable for placement of dredged material.

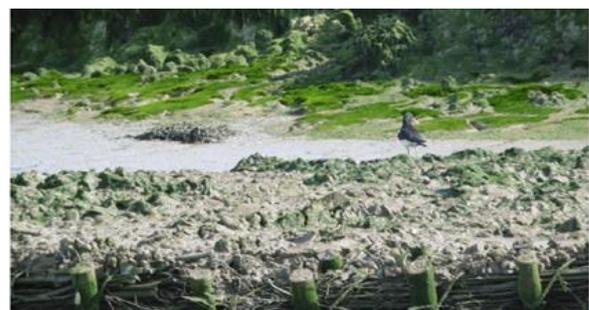
Figure 5. Visual evidence of Macroalgal colonisation on newly placed material- Cindery Island west

It is likely that this recent and pronounced increase in shear strength is partly due to the macroalgal colonisation observed onsite, facilitating the binding and stabilisation of the sediment. This is supported by visual observations of macroalgal biofilm colonisation on newly deposited dredged sediment, in May 2017 (Figure 5). That is indicating the start of pioneer seral succession. This is also explained by the intertidal nature of the sites, with regular draining leading to consolidation over time.

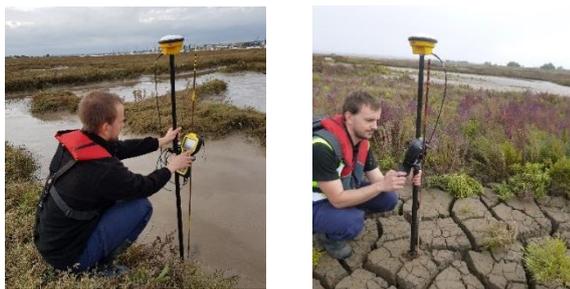
Figure 7. GPS measurement of base plate elevation

No dredging works took place during year 3, hence no monitoring was performed. However, drone monitoring, aerial elevation models and GPS readings were taken-recording consolidation of newly placed sediment (Figure 7).
